### **THEY *DO* BUILD 'EM LIKE THEY USED TO** *Equipment still running tirelessly since 1958*

LANCASTER, PA – June 14, 2006 –“They don’t build ‘em like they used to.” A phrase repeated more and more as mass production, global outsourcing and “throw-away” equipment evolves. However, some companies continue to provide high quality and proven reliability that lasts through the ages. Recently, Aerzen USA has come across a twin shaft rotary lobe blower that has been in service since 1958. “We are conservatively estimating that this blower has about 280,000 operating hours on it,” says aftersales manager Ralf Weiser. “The blower came to us for normal repair and servicing. It is been used in a flourmill and interestingly enough, they are using a spare blower of the same vintage and size.”

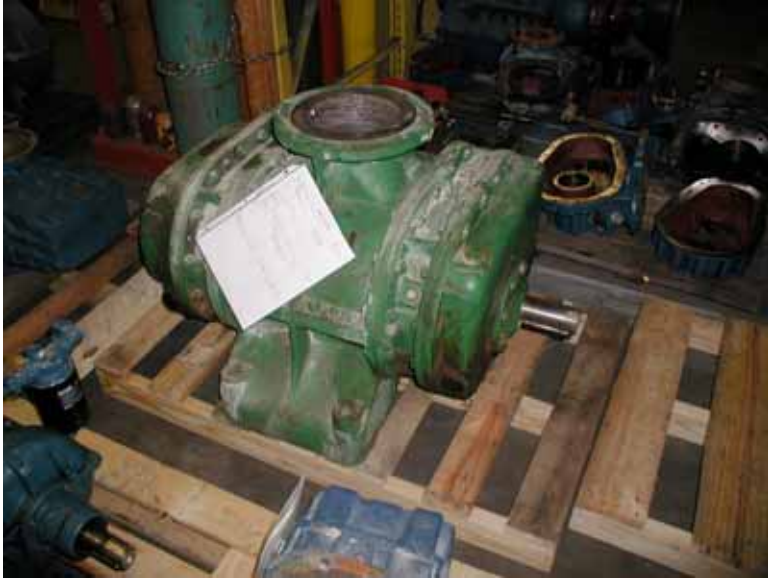
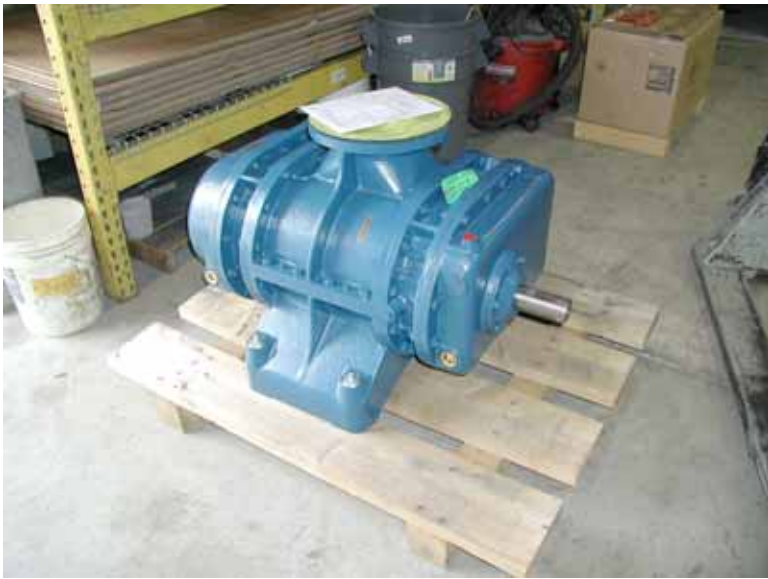
Upon tear down and evaluation, the machine was found to be in great working order with the exception of the rotor tip clearances. Due to the nature of the conveying system it is in, the small amounts of product in the air stream abraded the rotor sealing strips on the outer diameter of each rotor. “We use a proprietary method to build this strip up, which tends to be very tricky as the rotors are made of gray cast iron. Once the rotor rebuild is done, we can proceed with the overhaul as usual,” says Weiser. “The process will take about two weeks.”

Before and After: Aerzen blower still running since 1958

What should you do if you have an older blower and it needs to be serviced or overhauled? “When customers decide that they want a machine overhauled, they call our service group for an RMA,” states Weiser. “Once the unit arrives at Aerzen USA, it is put into a lean manufacturing type repair cell where it is placed in a FIFO (First In First Out) line up. Upon tear down and evaluation, the technician prepares an incoming inspection report and a bill of material that contains all the necessary parts and scope of work in order to return the blower or compressor to factory specifications.”

- All normal maintenance items such as the bearings, labyrinth seals, lip seals, lip seal wear sleeves, oil sight glasses, and O-rings are always replaced during an overhaul.
- The customer receives a quote, and the repair or overhaul commences once the okay has been given to proceed.
- All components are thoroughly cleaned and the machine is put together according to factory specifications.
- A final inspection report is prepared before the unit gets painted, filled with oil, and packaged for shipping.
